SURVEY REPORT:

LEAD PAINT AND ASBESTOS CONTAINING MATERIALS ASSESSMENT FOR THE PLUM ISLAND LIGHTHOUSE

**PLUM ISLAND ANIMAL DISEASE CENTER
PLUM ISLAND, NEW YORK**

February 2008

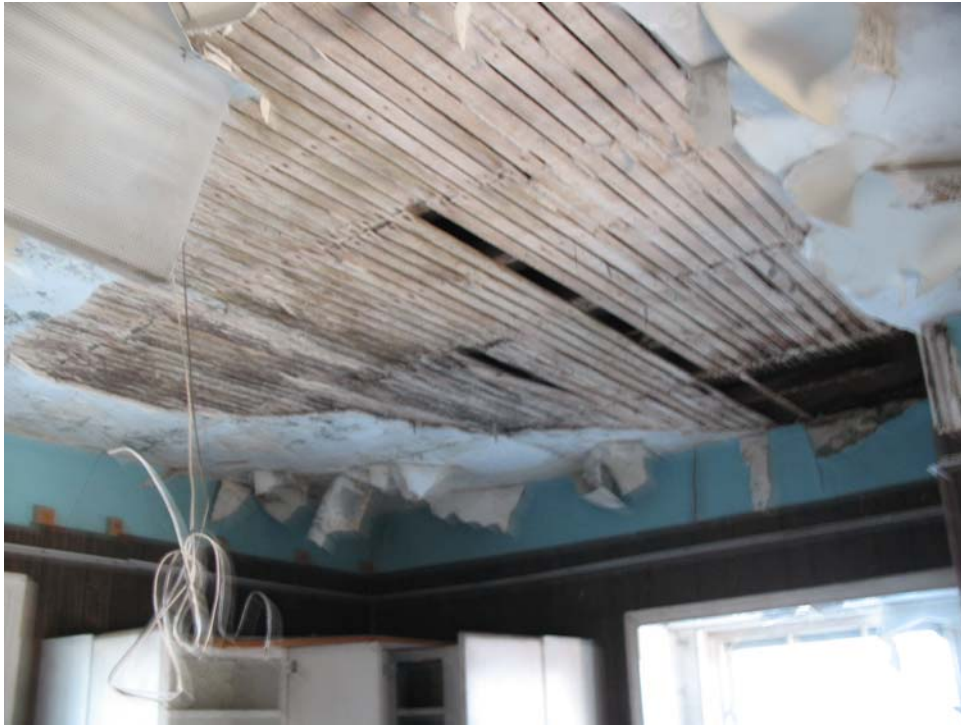
Pb Paint Sample #1: Paint and skimcoat plaster from the peeling kitchen ceiling was collected for analysis (Photo 1). This sample was collected to be representative of rooms with painted, non-tiled ceilings. Analytical results reveal that lead was present in the sample collected. The concentration of lead was reported at 80,000 ppm (8.0 percent).

Photo 1: Pronounced ceiling damage and peeling paint were found in the Kitchen. Damage was presumably due to past roof leakage. Pb Sample #1 was collected from this location.

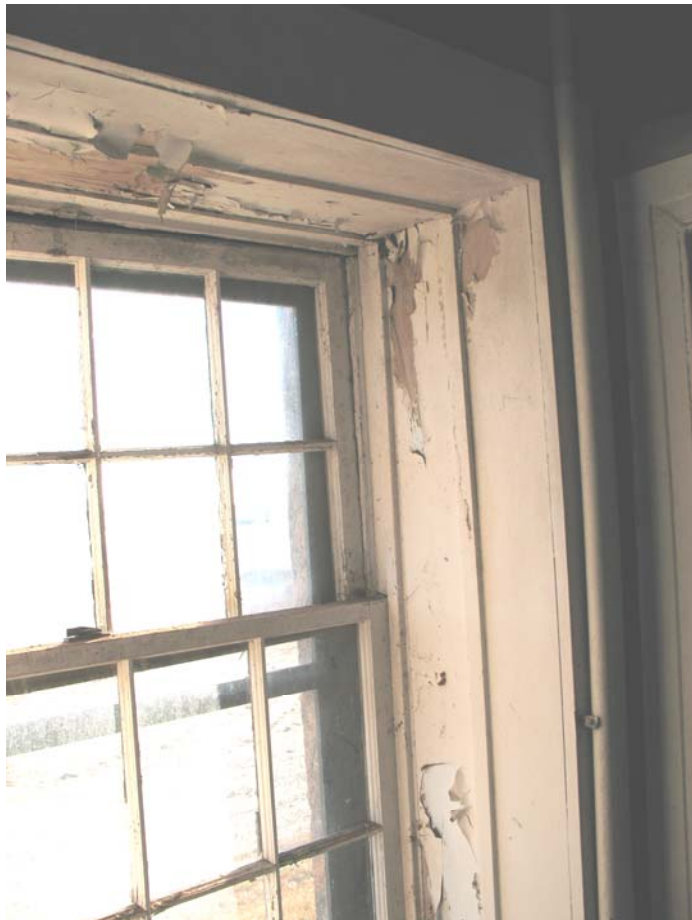
Pb Paint Sample #2: This sample was collected from a first floor window frame and was selected to be representative of all window systems in the building (Photo 2). The paint was white in color and many layers thick. The appearance and condition of the paint was visually identical to that of all windows inspected within the structure. Analytical results reveal that lead was present in the sample collected. The concentration of lead was reported at 1700 ppm (0.17 percent).

Photo 2: Peeling white paint appeared prominently around every window in the Lighthouse. Pb Sample #2 was collected from this first floor, "Living Room" location.

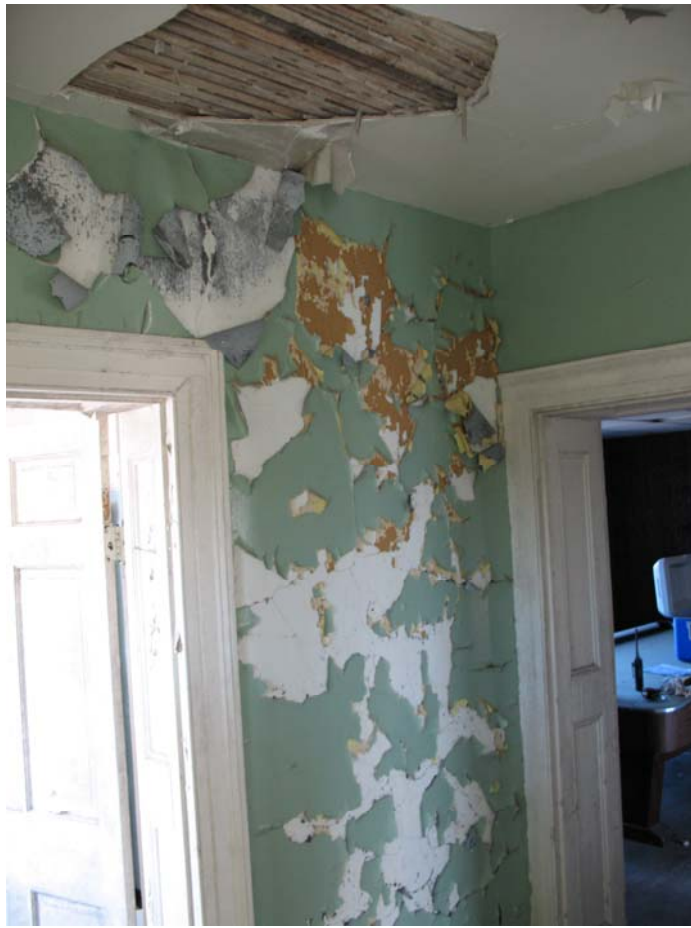
Pb Paint Sample #3: Sample #3 was collected from the Entry Hall of the first floor, which is located adjacent to the formal entrance to the Lighthouse. Unlike most of the common areas of the first floor, hall walls and stairwells on all floors were not covered with wood veneer paneling. Large sheets of paint were found peeling from the plaster surface; paint fragments littered the floor as a result (Photo 3). Close examination of the paint and wall surfaces in the Entry Hall revealed at least seven different layers of distinctly colored paint. Working up from what appears to have been the earliest base coat paint layer, the following colors were observed: plaster white, black, dark grey, carmel, creamy yellow, pastel yellow, and blue green. The outer (most recent) blue green color was the most common wall covering color observed throughout the first and second floors of the Lighthouse. This color was also, in cases where it could be observed, found behind the wood veneer paneling. A representative sample of this multi-layer paint was collected for analysis because of its multiple paint layers. Analytical results reveal that lead was present in the sample collected. The concentration of lead was reported at 71,000 ppm (7.1 percent).

Photo 3: Dramatic peeling of wall paint was noted in the entry hall. Some damage to ceiling plaster was also apparent. Multiple layers of distinctly different colors of paint were noted in the sample collected for analysis. Pb Sample #3 was collected from this particular wall.

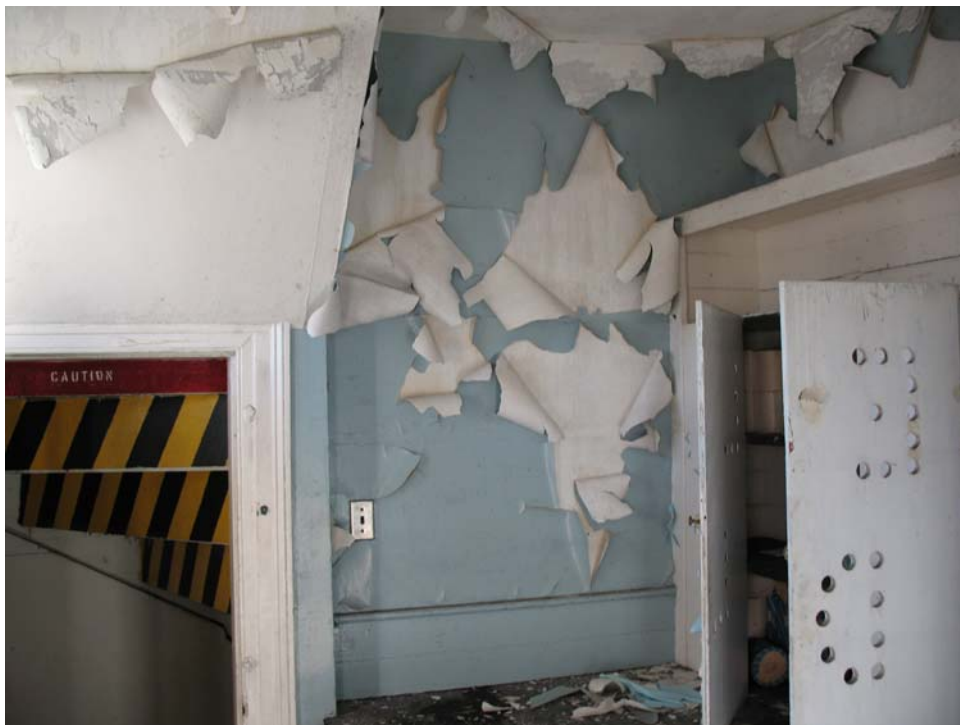
Pb Paint Sample #4: This sample was collected from the large sheets of robin egg blue paint found peeling from the walls in the first floor storage room (Photo 4). This blue paint, which differed in color

from other blue or blue-green paints observed within the Lighthouse, was collected solely because of its unique coloration. No underlying colors (paint layers) were noted in field notes created during the survey. Analytical results reveal that lead was present in the sample collected. The concentration of lead was reported at 80,000 ppm (8.0 percent).

Photo 4: Dramatic peels of paint were also observed in the first floor Supply Pantry. Pb Sample #4 was collected from this wall because of its unique color.

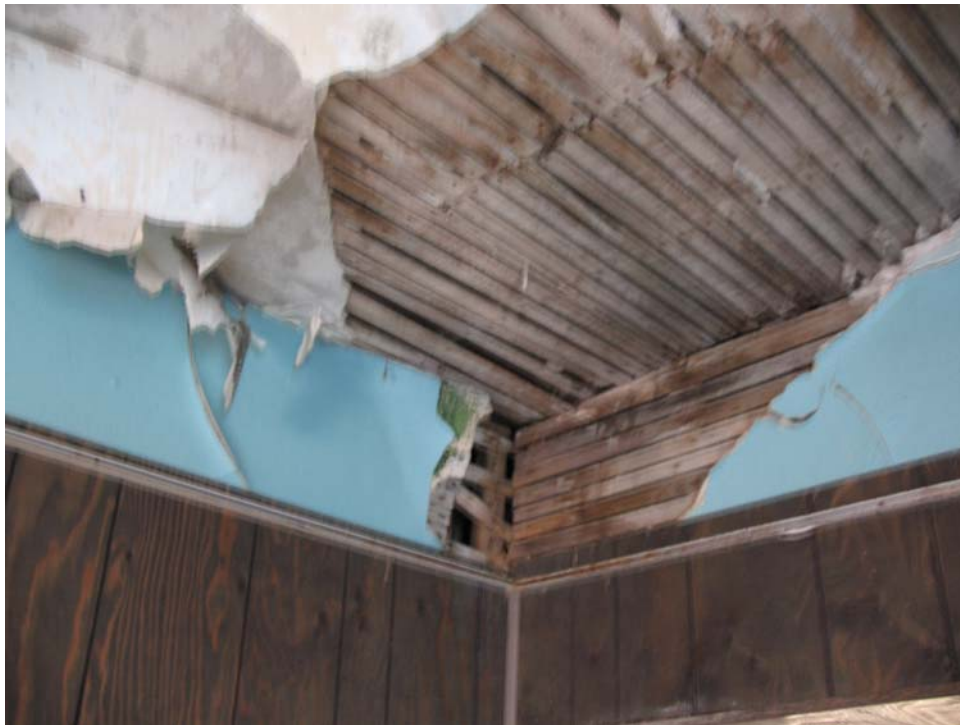
Pb Paint Sample #5: A sample of the bright blue wall paint observed in the Kitchen between the former drop/false ceiling system and the original plaster and lathe ceiling, was collected for analysis (Photo 5). This blue paint, which differed in color from other blue or blue-green paints observed during the survey, was collected because of its unique coloration. No underlying colors (paint layers) were noted in field notes created during the survey. Analytical results reveal that lead was present in the sample collected. The concentration of lead was reported at 78,000 ppm (7.8 percent).

Photo 5: A unique color of blue wall paint was noted in Kitchen between the former drop/false ceiling (removed) and the original plaster ceiling. Pb Sample #5 was collected from this location.

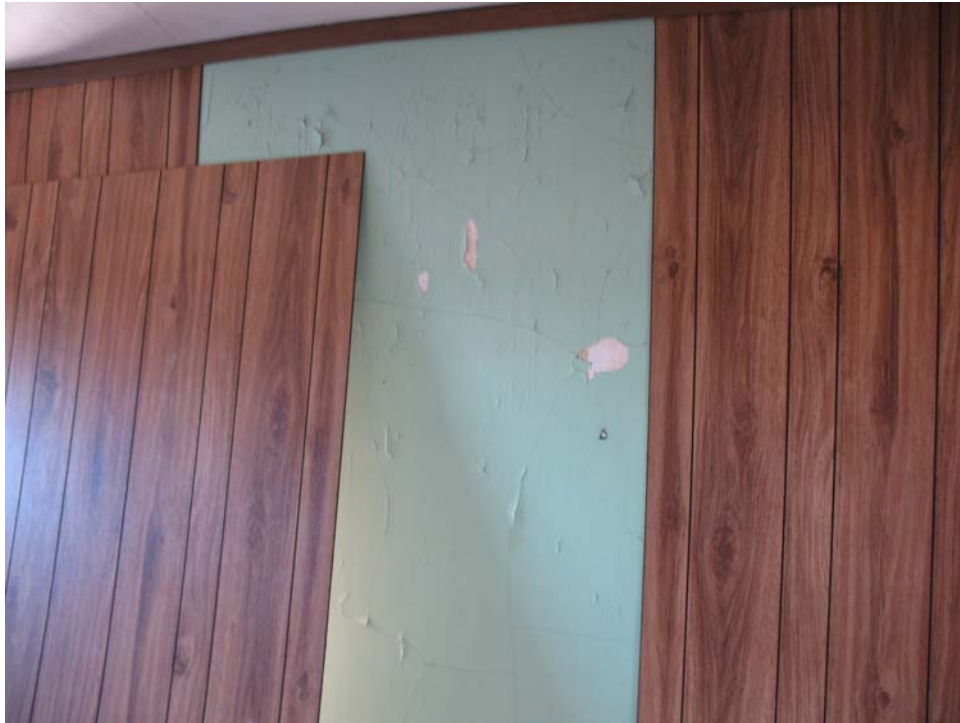
Pb Paint Sample #6: A sample of blue-green paint recovered from behind a wood veneer panel that had fallen away from the original lathe and plaster walls. This particular sample was obtained from the East Bedroom of the second floor (Photo 6). This paint color appeared somewhat different from the blue-green color that appears prominently throughout most of the Lighthouse. This difference in color/tone may be attributable to its having been protected from light, dirt, and general exposure, by the paneling. This sample was considered to be representative of wall paint likely found behind all paneling on the second floor. Analytical results reveal that lead was present in the sample collected. The concentration of lead was reported at 70,000 ppm (7.0 percent).

Photo 6: An example of the blue-green wall paint found in the second story East Bedroom. This color of paint was presumed to be behind most wall panels. The paint's overall condition was superior to that of similar blue-green painted surfaces in other, unprotected areas of the Lighthouse. Pb Sample #6 was collected from this locale.

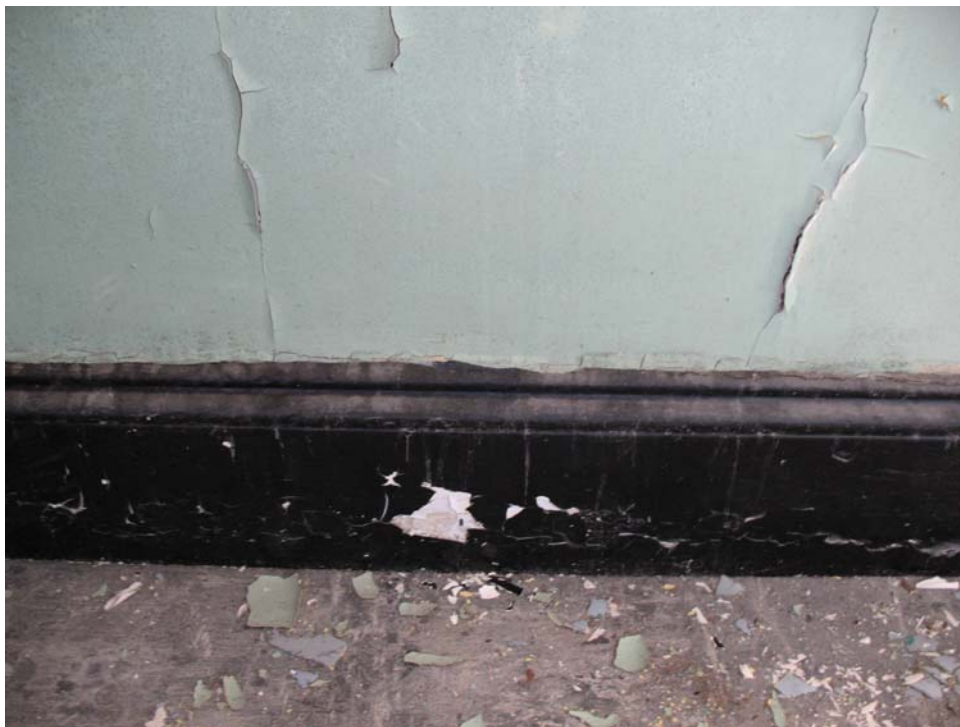
Pb Paint Sample #7: Paint scrapings were collected from the wide baseboard trim found in the hall and stairwell of the second floor. This black trim paint was unique and was not found on any other surfaces within the structure. The paint was generally in good condition and exhibited only moderate peeling (Photo 7). No underlying colors of paint were noted in association with the sample collected. Analytical results reveal that lead was present in the sample collected. The concentration of lead was reported at 79,000 ppm (7.9 percent).

Photo 7: Baseboards were painted black in the hall and stair areas of the Lighthouse. This was the only instance where black paint was noted in the structure. Pb Sample #7 was collected in from a section of the second story baseboard.

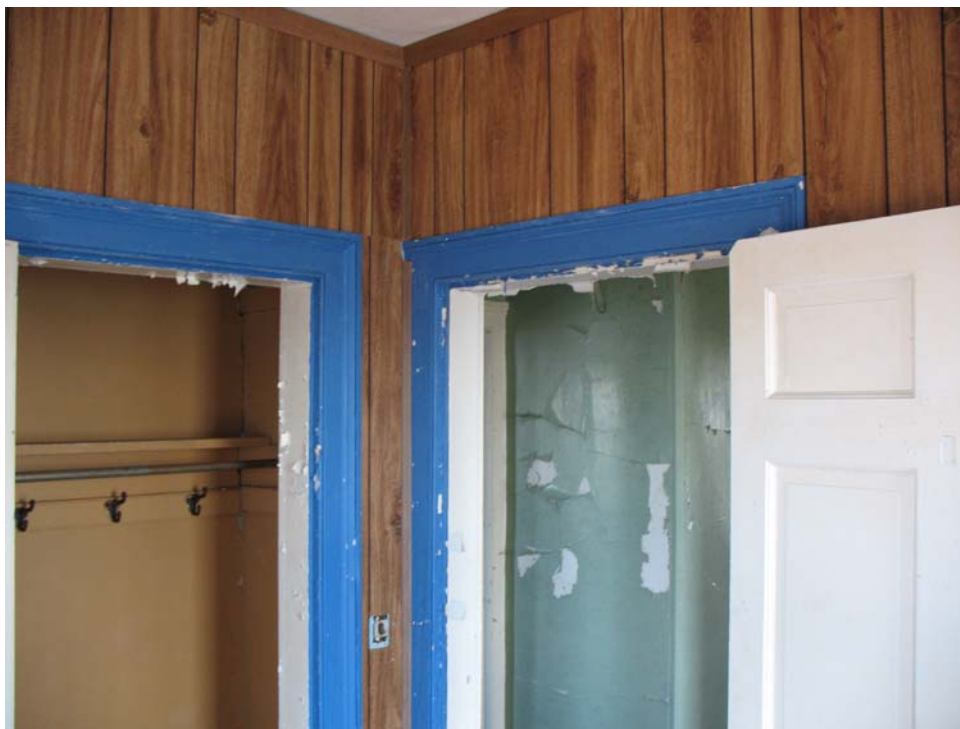
Pb Paint Sample #8: Bright blue trim paint found around door and window frames in the small, West Bedroom on the second floor was collected for analysis (Photo 8). This paint color was also unusual and appeared nowhere else in the building. Older, underlying layers of white paint were also associated with the blue paint chips collected from this room. Analytical results reveal that lead was present in the sample collected. The concentration of lead was reported at 5,400 ppm (0.54 percent).

Photo 8: Yet another unique blue painted surface, visually similar in tone and color to that used on PIADC's ferry fleet. This example was found only in the South Bedroom on the second floor. Pb Sample #8 was collected from the entry door frame.

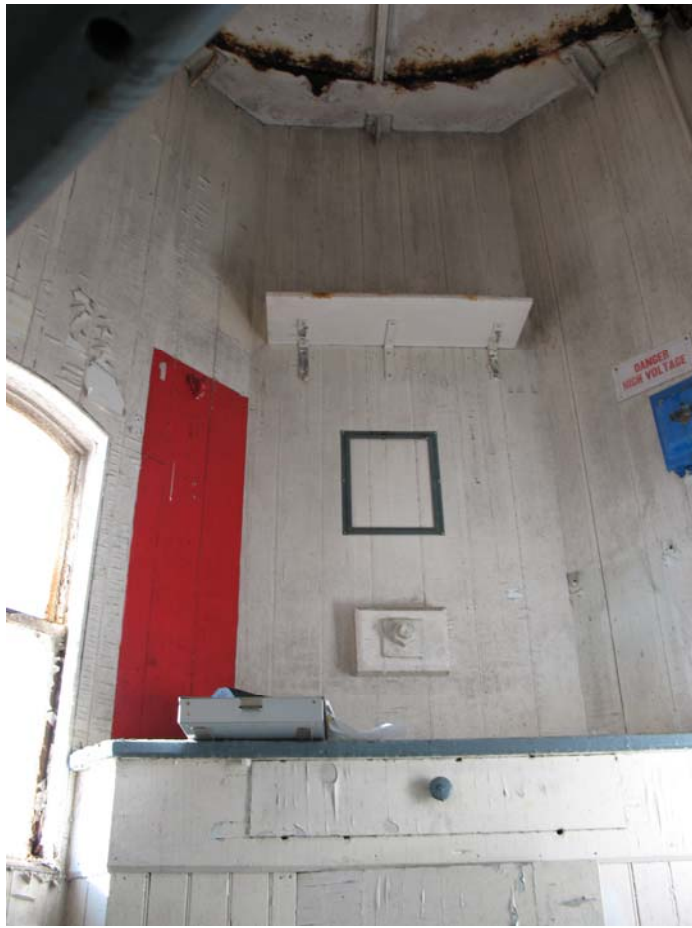
Pb Paint Sample #9: Peeling white paint was collected from the plank board paneling found within the Service Room (Photo 9). The sample was determined to be representative of all wall surfaces in this room. Analytical results reveal that lead was present in the sample collected. The concentration of lead was reported at 85,000 ppm (8.5 percent).

Photo 9: Peeling white paint was observed on all of the board plank walls in the Service Room. Pb Sample #9 was collected from the vicinity of the window and was determined to be representative of the room's entire painted surface.

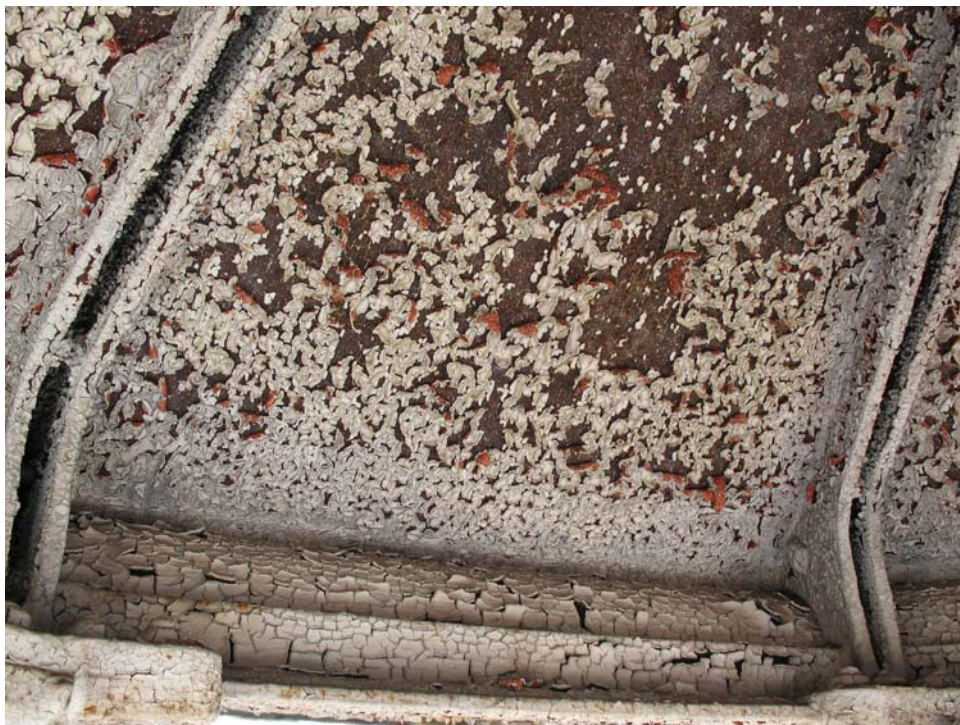
Pb Paint Sample #10: Peeling white paint from the metallic, bell-shaped ceiling of the Lantern Room was obtained for analysis (Photo 10). This paint sample was considered to be representative of all painted, metallic surfaces in this cast iron structure. While the paint and underlying metal surface of the collection site was significantly deteriorated, surficial conditions elsewhere in this circular room much less pronounced. Analytical results reveal that lead was present in the sample collected. The concentration of lead was reported at 91,000 ppm (9.1 percent).

Photo 10: Heavy corrosion and peeling paint in the bell-shaped roof of the Lantern Room. Pb Sample #10 was collected from this west-facing roof panel.

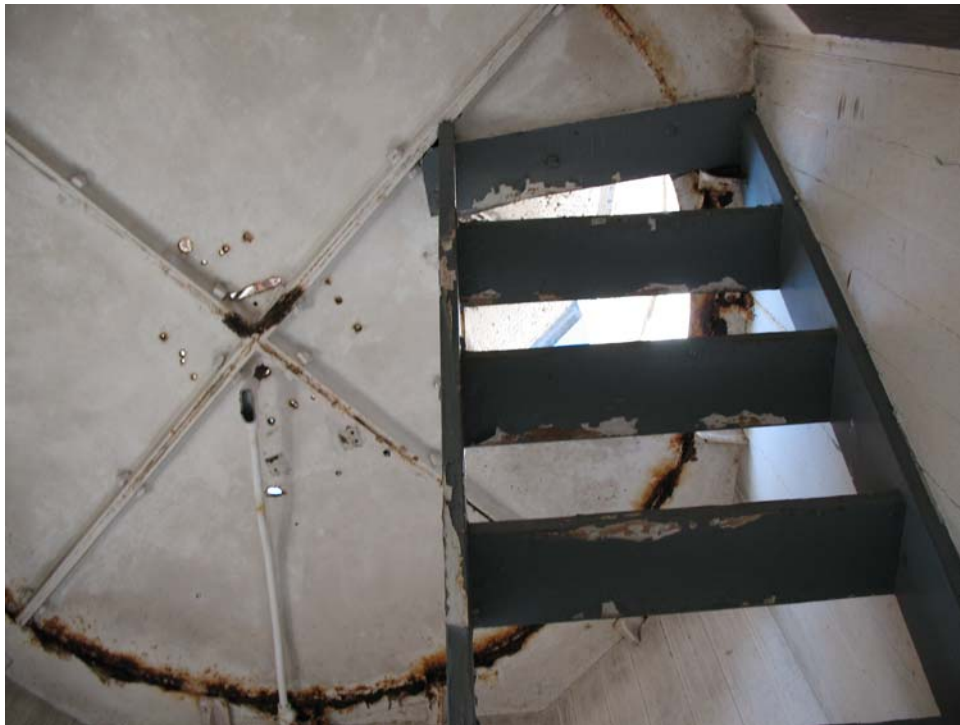
Pb Paint Sample #11: Grey paint was collected from wooden banister and stairway tread surfaces found in the stairwells leading to the Attic, Service Room, and Lantern Room (Photo 11). The paint sample collected appeared to be representative of all staircase woodwork in these areas. Analytical results reveal that lead was present in the sample collected. The concentration of lead was reported at 82,000 ppm (8.2 percent).

Photo 11: Example of the grey paint used on all upper story stairwell handrails and stair treads. Pb Sample #11 was collected from the stairs leading from the second floor to the Attic. Photo 11 above shows the access stairs between the Service Room to the Lantern Room.

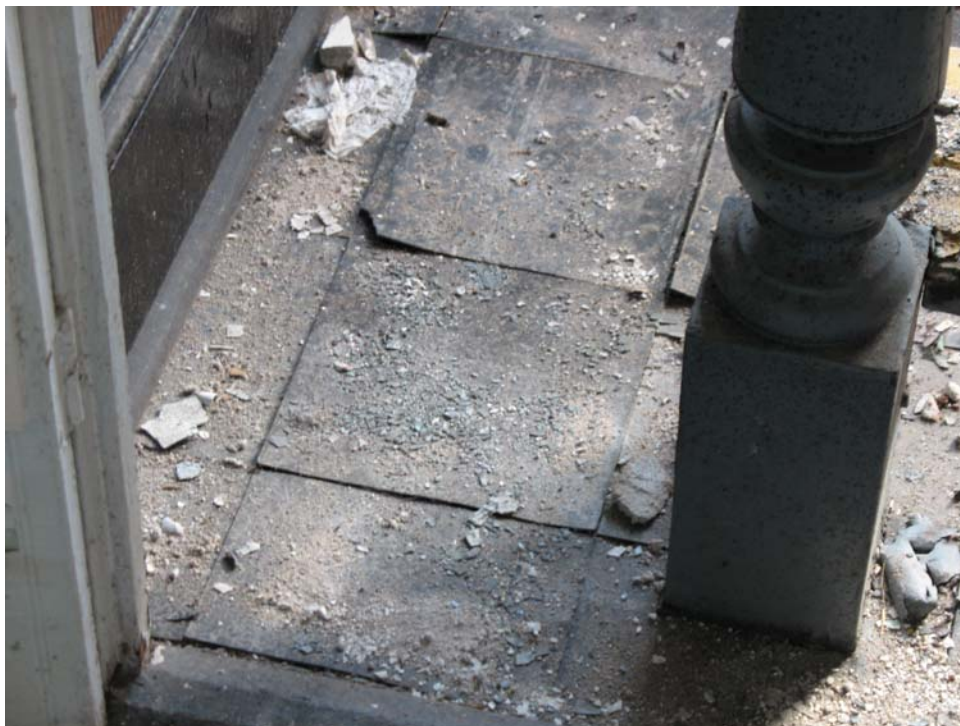
ACM Sample #1: A sample of the black, 9 x 9-inch floor tiles common to most floors within the building was selected for analysis (Photo 12). The sample was comprised of both the tile and the underlying black, tar-like mastic that originally held it in place. Both the tile and the mastic were evaluated. The

Photo 12: Typical example of the black 9x9-inch floor tiles commonly found throughout the Lighthouse. ACM Sample #1 was collected from this landing area between the second floor and the Attic. Both the tile and the underlying mastic were evaluated for asbestos content.

- Floor tiles and mastics, while shown to contain low percentage asbestos content, need to be removed in any case. All of these floors are brittle, cracked, and lightly adhered to the underlayment. If the tiles were intact, they could be sealed and maintained without hazard. However, due to deterioration caused by temperature, humidity, and time, all such floors need to be removed and replaced for general safety (and appearance) purposes. Once removed (and the interior spaces are cleaned of paint and ACM residues), modern, non-asbestos tiles could be reinstalled. Restoration of the original wooden floors of the building would be significantly more costly (and maintenance intensive) than a replacement tile option.

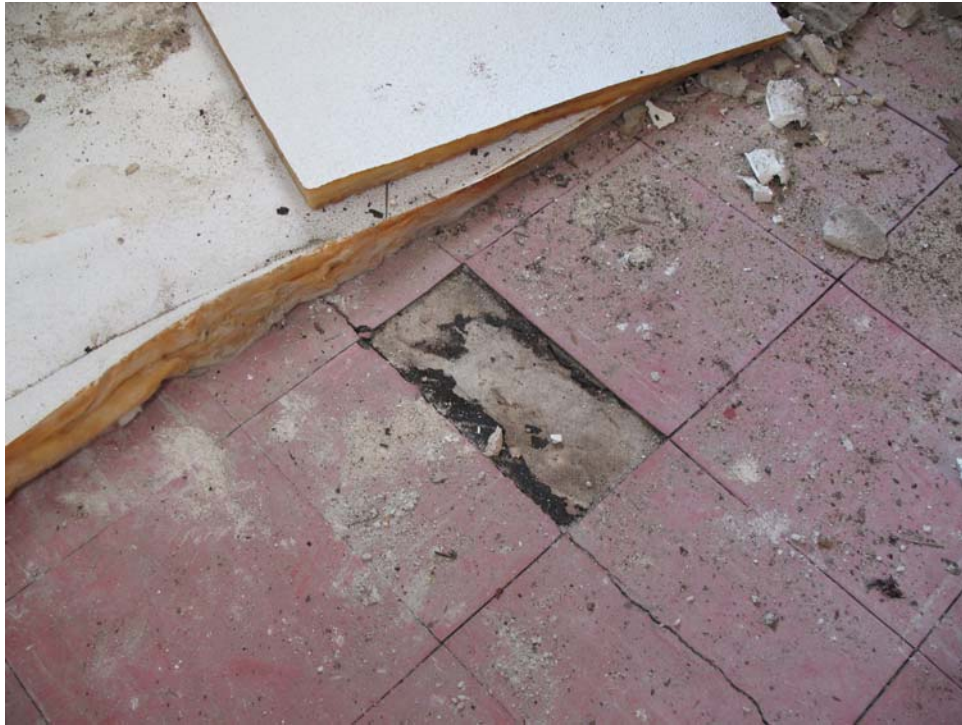
ACM Sample #2: This sample was collected from the red tile floor found in the Office on the second floor (Photo 13). These tiles were also 9 x 9 inches in size. Black mastic visually identical to the black tile selected in Sample #1 above was also present on the back of the sample selected. Once again, both the tile and the mastic were evaluated. The analysis revealed chrysotile asbestos in both the tile and mastic. The concentration of asbestos in each sample was determined to be between 1 and 3 percent, by area.

Photo 13: Example of the red, 9x9-inch tiles found in the second floor Office. This was the only room observed to have red tiles. ACM Sample #2 was collected from the broke tile section shown above. Both the tile and mastic were examined for asbestos. The adjacent drop/false ceiling tiles were also evaluated as potential ACM items.

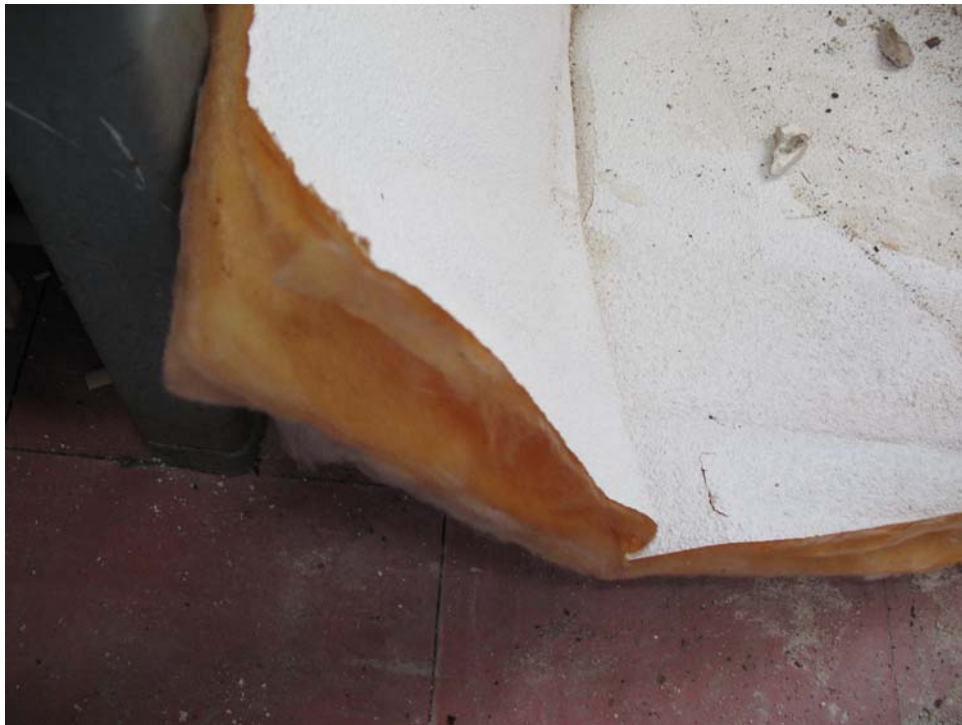
ACM Sample #3: Sample #3 was collected from a collapsed drop/false ceiling tile found in the second floor Office (Photo 14). This tile appeared to be of the same construction as those intact tiles on the first floor of the Lighthouse. The analysis of this material revealed that it was comprised of fiberglass and contained no detectable amounts of asbestiform minerals.

Photo 14: A detailed view of a typical drop/false ceiling panel. The white, outer layer was made of a soft, pliable plastic material. The insulation materials (pink/orange) was tested and identified as fiberglass. ACM Sample #3 was collected from the second floor Office panel pictured above.

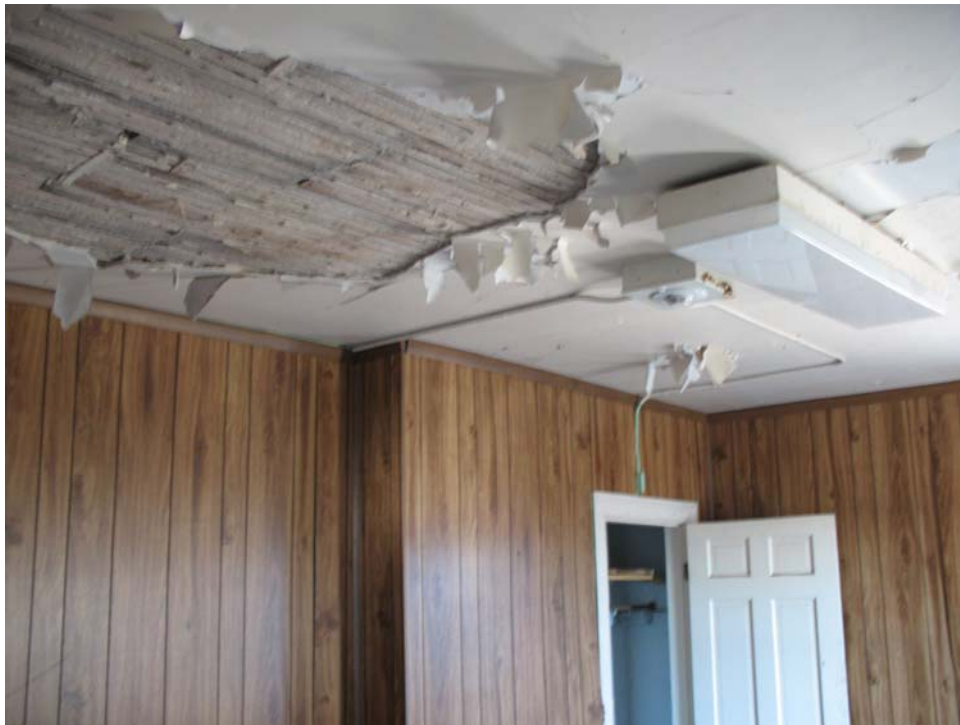
ACM Sample #4: A sample of the deteriorated plaster ceiling in the East Bedroom on the second floor was collected for analysis (Photo 15). The analysis of this materials indicated that fibrous materials in the in the plaster matrix were comprised of cellulose (between 10 and 20 percent, by area). No detectable amounts of asbestiform minerals were present.

Photo 15: A sample of ceiling plaster was obtained for ACM analysis from the East Bedroom, on the second floor. Small fibers were visible in the sample (ACM Sample #4).

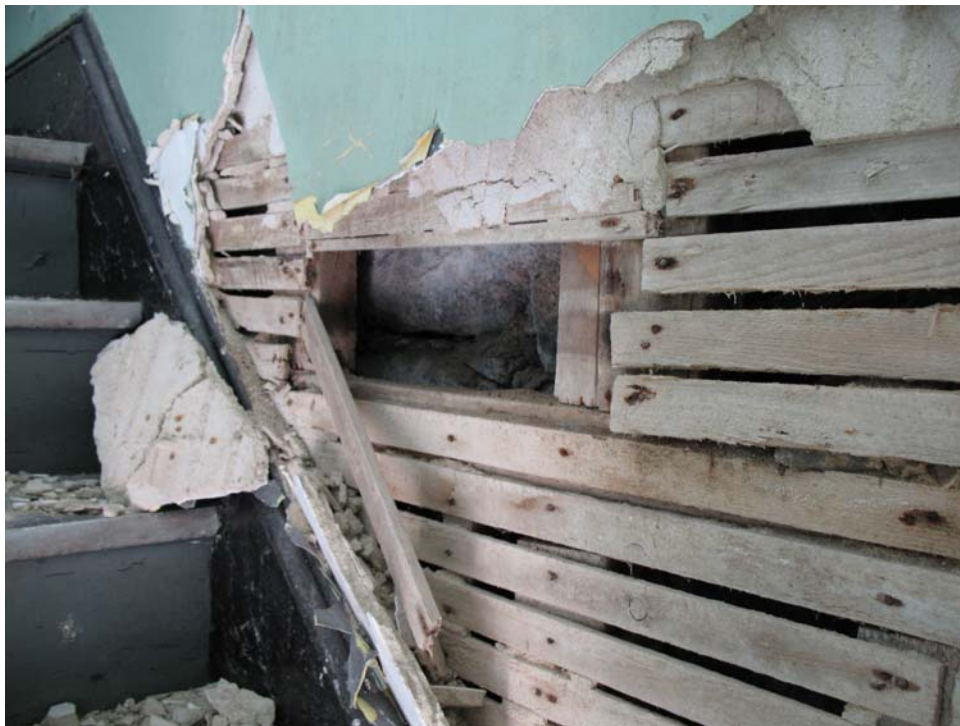
ACM Sample #6: Sample #6 was obtained from the damaged plaster wall in the stairwell between the first and second floor (Photo 16). Fibers appeared to be present in this damaged material, so a small piece of the wall was collected for further analysis. The laboratory determined that the sample was comprised of the two distinct layers or "phases": plaster and skimcoat. The analytical results of this analysis revealed a trace amount (<1%) of chrysotile asbestos in the plaster; however, no detectable asbestiform mineral content was observed in the skimcoat.

Photo 16: Example of broken lathe and plaster in the stairwell between the first and second floor. A plaster sample (ACM Sample #6) containing small fibers was collected from this location. As shown in this image, no insulation was observed between walls or floors in any areas where damage permitted visual inspection of interstitial spaces.

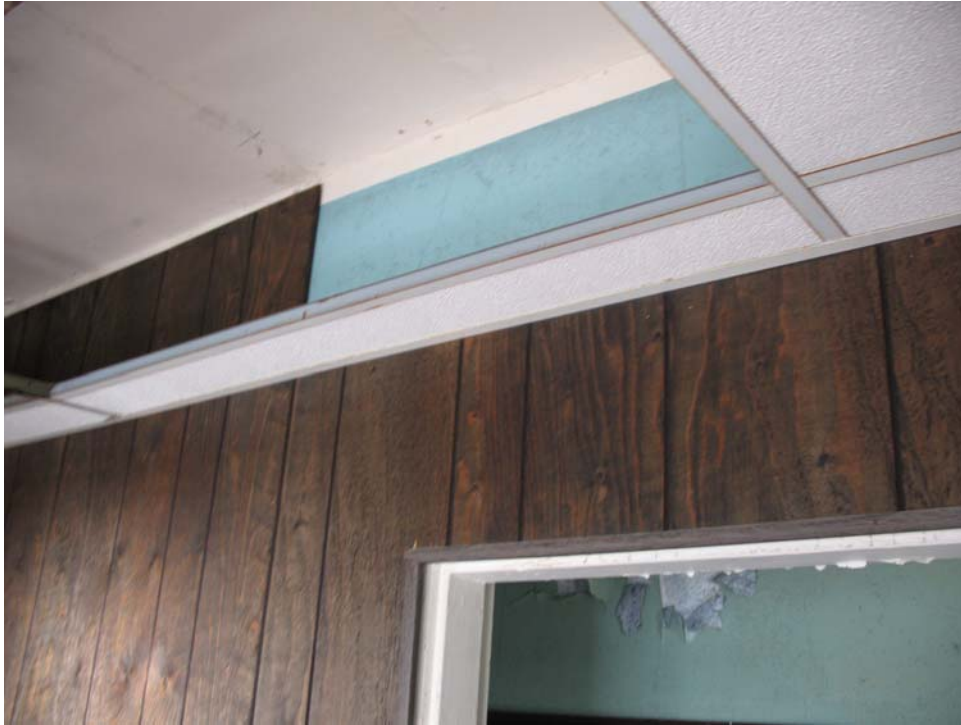
ACM Sample #7: A sample of the acoustical tile glued to the original plaster ceiling on the first floor of the Lighthouse was obtained for analysis (Photo 17). The interior of this sample was very fibrous and was a yellow-orange color. Analysis of the material revealed that is was largely comprised of cellulose (80 to 90 percent, by area). No detectable asbestiform mineral content was noted.

Photo 17: Example of acoustic ceiling tiles (white) glued to original lathe and plaster surface. ACM Sample #7 was collected from one of these tiles and was found to be made of cellulose. The partially intact drop/false ceiling system also seen in this image was installed sometime after the acoustic tiles. These drop/false ceiling tiles were primarily composed of fiberglass.

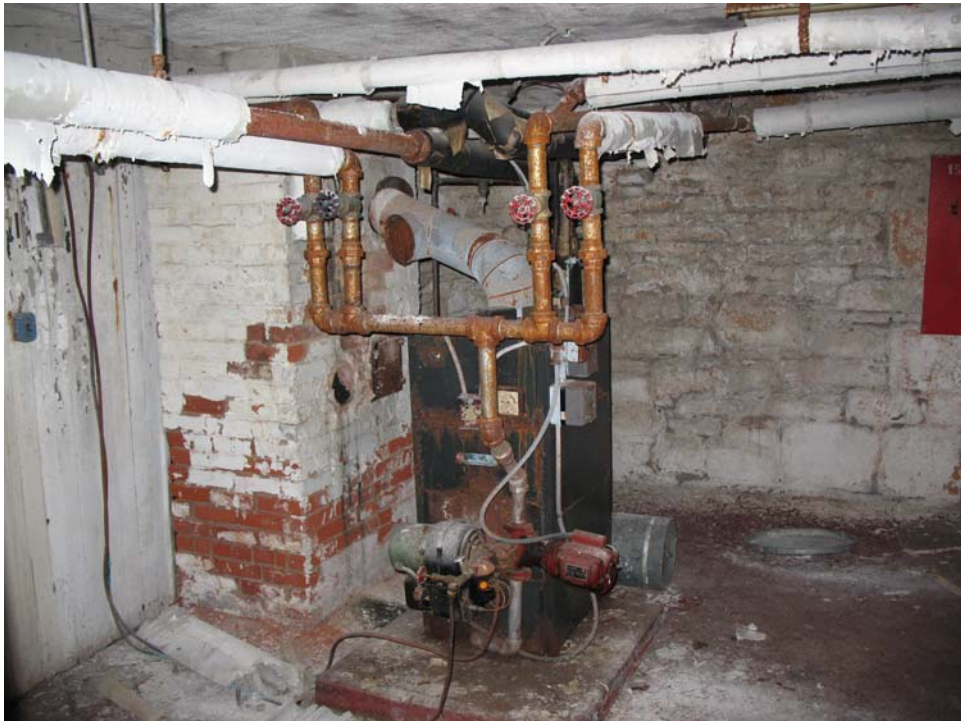
ACM Sample #8: A representative sample of the insulation covering the Basement water pipes was collected for confirmation analysis (Photo 18). This material was visually identified as asbestos by the Survey Team members. The insulation was in very poor condition; much of it had fallen to the floor in pieces. The confirmation sample was identified as chrysotile asbestos, and was reported to contain between 40 and 50 percent, by area, of this asbestiform mineral. Another 30 to 40 percent of other, presumably non-hazardous fibrous materials were reported to be present in the matrix of the insulation.

Photo 18: View of the hot water heating system and asbestos-wrapped water pipes in the Basement. The pipe insulation was sampled (ACM Sample #8) for confirmation purposes. All of this insulation was significantly deteriorated and should be removed in the near term before it completely disintegrates. Pipe insulation was observed throughout the Basement.

- Asbestos removal is desperately needed in the basement of the structure, regardless of future access to the Lighthouse. Approximately 200 to 300 linear feet of deteriorating asbestos pipe wrap is present in this area. Portions of this insulation have already deteriorated and dropped to the floor. Significant dust and insulation fragments are present throughout this area. Near term removal of this material while most of it is still intact would significantly mitigate future remediation costs and levels of effort.

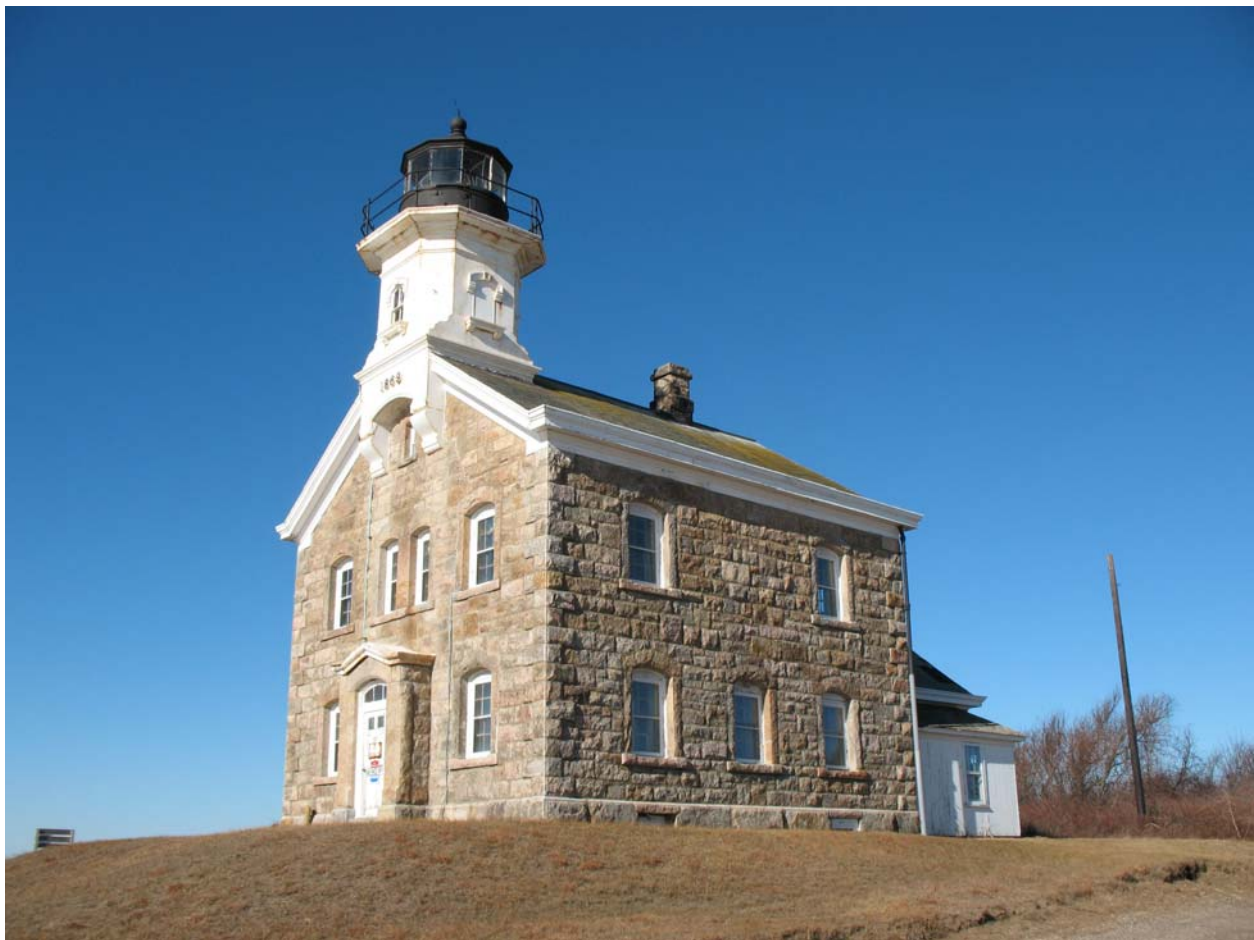
ACM Sample #9: The final ACM sample collected from the Lighthouse actually came from an exterior structural element of the building (Photo 19). A portion of a broken roofing shingle was collected from the ground on the eastern side of the Lighthouse. The tile was described in field notes as having hard, brittle, ceramic tile-like attributes. The shingle was later characterized in laboratory documentation as transite. Analysis revealed chrysotile asbestos content between 10 and 20 percent, by area, within the shingle sample matrix.

Photo 19: The roof of the Lighthouse (and kitchen at rear- partly visible) is covered with transite shingles. A broken piece of shingle picked from the ground in the vicinity of the enclosed porch (white lean-to structure). Laboratory analysis revealed substantial asbestos content in the shingle material. This sample was identified as ACM Sample #9. Roofing on the enclosed porch may not be transite based on its general, visual appearance.

- Continued vigilance of the condition of the roof is necessary to maintain the overall good condition of the structure. The asbestos content of the existing roof does not pose a hazard as long as its individual tiles are not subject to grinding, cutting, or other abrasive activities. No extraordinary actions regarding the roof appear necessary at this time.
